# **Rooftop PV System Inspection Checklist**

Anon / Anon / Anon / Anon Com				Complete	
Score	143 / 186 (76.88%)	Flagged items	8	Actions	16
Project Inf	fo				
Client					Anon
Site Addro	ess				Anon
System D	esigner				Anon
System In	nstaller				Anon
Solar Info					
DC Solar (	Capacity (kW)				100
AC Solar Capacity (kW) 100			100		
PV Modul	e Make & Model			Trina 500	0W tsm-500DE18M(II)
Solar Inve	erter Make & Model				SMA core 1 50kW x2
Solar Rac	king Type				schletter
Battery In	fo				
Battery Capacity (kWh) -					
Battery C	Battery Converter Power (kW)

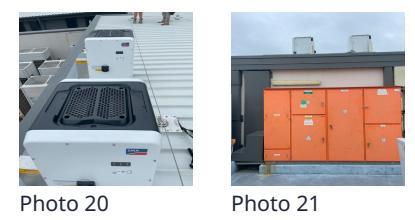
Inverters are installed in direct sunlight.

Installer to either:

a) install a shad to cover the inverters from direct sunlight.

b) provide a manufactures declaration from SMA that this installation was fine and the warranty will hold.

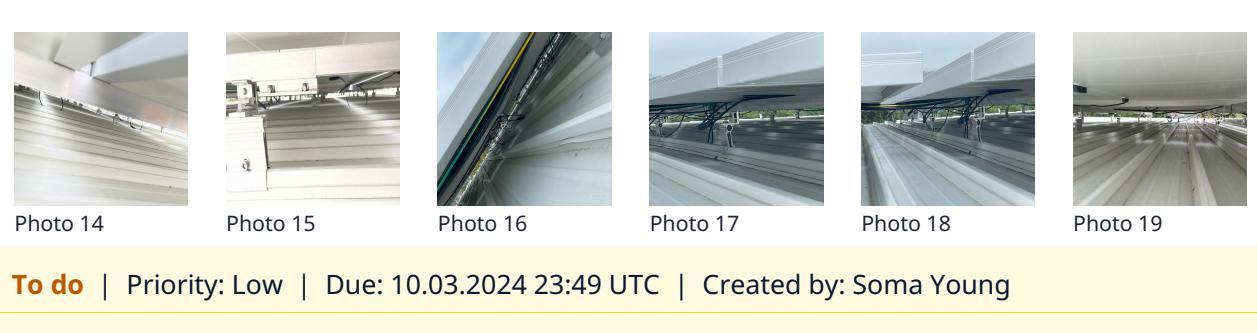
In multiple locations string and earth cables were not appropriately secured and touching the roof.

Installer to secure string cables such that they are not in contact with the roof.

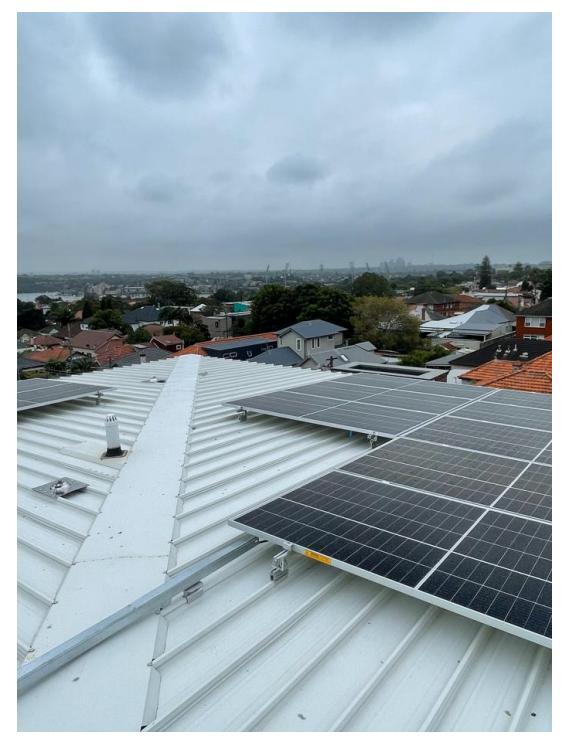
Photo 3

Upon review some panels on the eastern face appeared to be within the purple zone of the roof from the structural engineering. This zone required 3 rails however 2 were uses.

It appears possible that a couple of the panels are in the red zone which no panels were to be installed but exact measurements were not take during the audit on site.

RED ZONE CORNER ZONE - NO MODULES TO BE INSTALLED IN THIS ZONE

Installer to ensure no panels are located in the red corner zones. If any panels are located here they are to be moved.

Installer to either: a) move panels from purple zone to another zone. b) reinstall panels in purple zone with 3 rails.

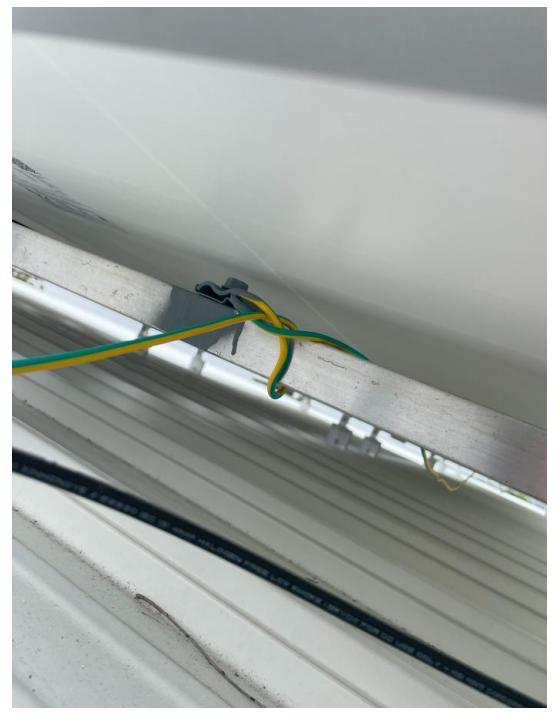
Photo 11

Some sections of metal cable tray containing DC cables were not earthed. 4mm earth was used for all array frame and rail earthing. I believe the inverters used were non-separated PCE with powered neutral. If no overcurrent protection is used the inverters earth cable size must be used (see table 4.6 and figure 4.13 from 5033).

Installer to either: a) replace all array frame earth cable with the same size as the inverter. b) install DC overcurrent protection to allow smaller cable.

Installer to earth all DC cable tray

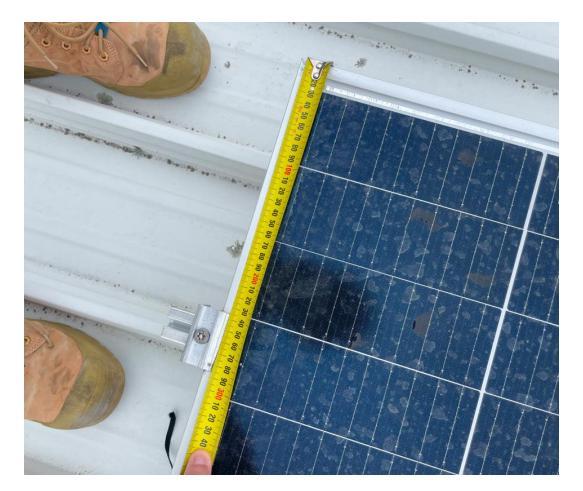
Photo 10

Panel clamps were often outside of panel clamping zones from panel installation manual (350-450mm). From what was measured and what was discussed with the installer onsite 200-600mm was used. Also 1 panel appeared to have its mid clamps not appropriately tightened.

Installer to ensure all clamps are appropriately tightened.

a) get written permission from Trina to use 200-600mm clamp zones for this install. b) reinstall all panels within acceptable clamp zones

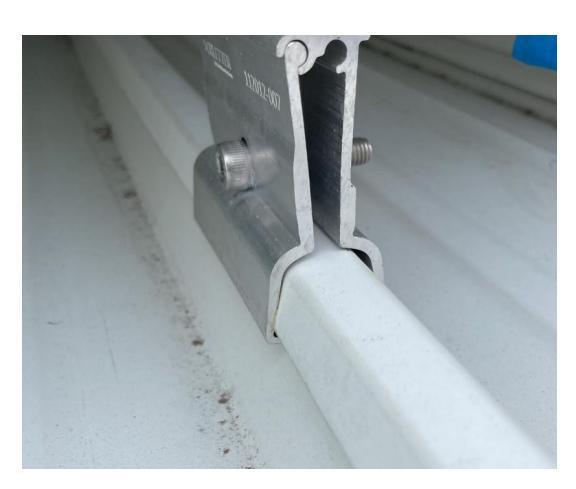
Photo 12

Kliplok clamps used did not have any rubber stopper preventing contact with the roof sheets.

Installer to provide a manufactures declaration that this is fine and warranties will be upheld.

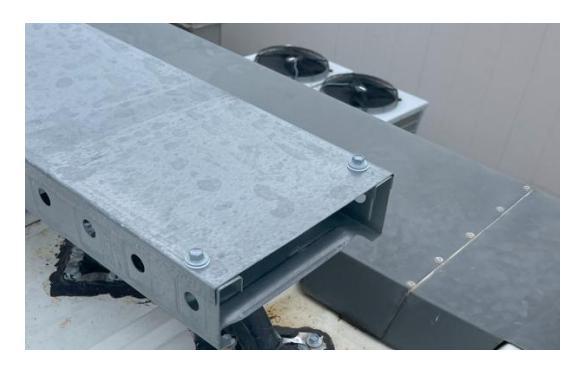
Photo 13

One end of cable tray was not closed however it is very minimal as the cable tray was short. This would just be an Opportunity for Improvement.

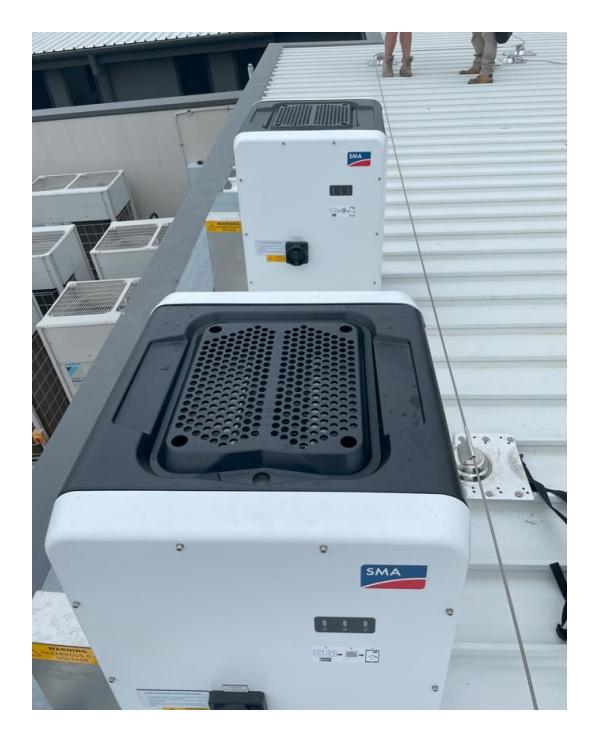
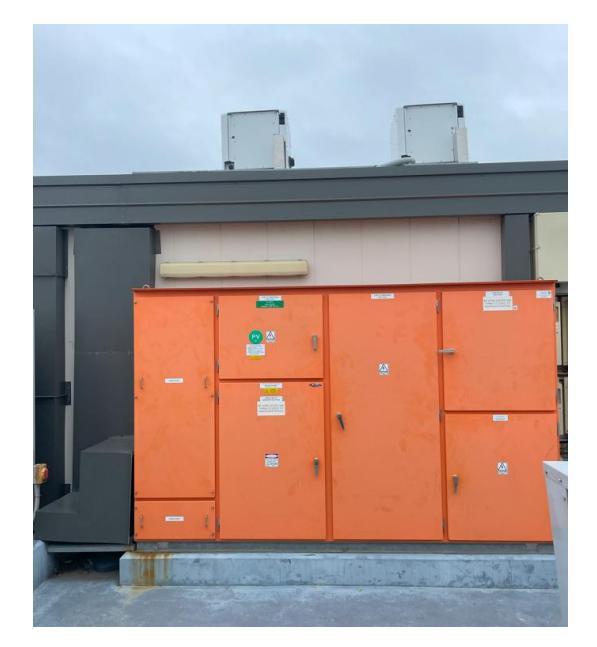
Photo 20

Inverters are installed in direct sunlight.

Installer to either:

a) install a shad to cover the inverters from direct sunlight.

b) provide a manufactures declaration from SMA that this installation was fine and the warranty will hold.
